## Conference Rooting for #3BillionTrees 20 March 2024, Brussels

## Post Fire Management in Cyprus (The Solea Forest Fire)

## Post-Fire Management Plan of Solea Area

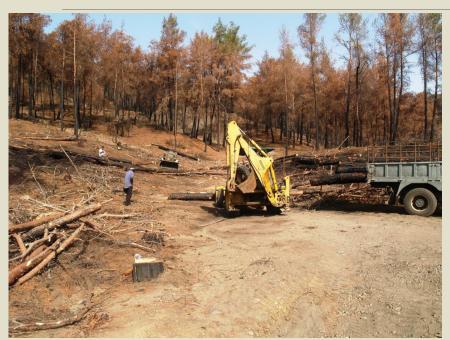
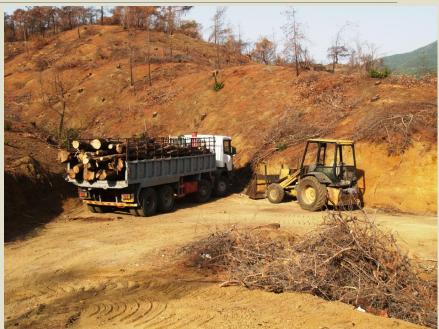
## **Salvage Logging**

Logging and removal of burnt standing timber are aiming to:

- i. The preservation of the top soil and the recovery of its properties,
- ii. Reduction of the risk of the appearance of harmful insects due to the large volume of burnt wood,
- iii. Accelerate breakdown of hydrophobic topsoil during salvage logging, while improving infiltration capacity and
- iv. Increase land cover from logging residues.

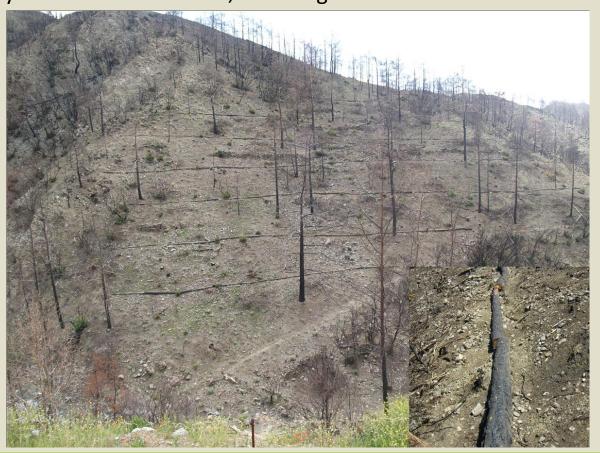
## **Contour log-terraces**

Contour log-terraces aimed to reduce soil erosion and improve soil conditions for successful regeneration of pine species. Contour log-terraces are rows of burnt logs, approximately 15-30 cm in diameter, set along contour lines.

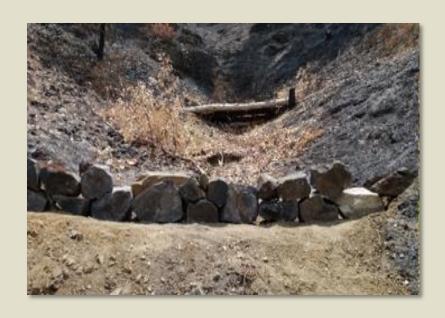
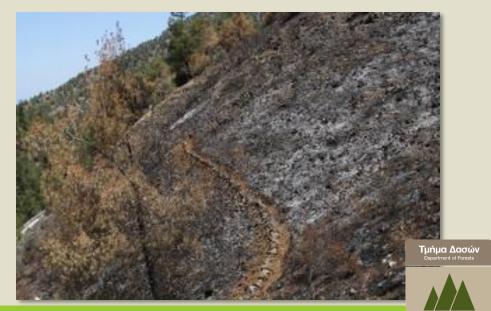
## Opening of shallow grooves on the slopes and placing stones on the underside

The purpose of this measure was to prevent soil erosion and to create suitable conditions for the successful regeneration of *Pinus brutia*.

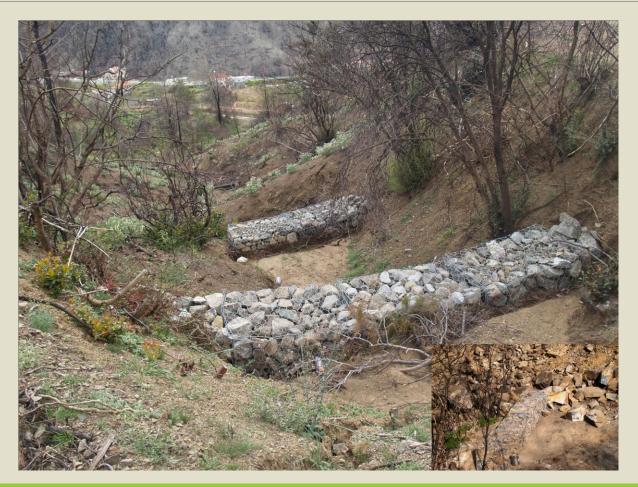
Gabions are permanent artificial works (series of cable cages, filled with stones) which in the particular case were constructed in the beds of large streams where floods were more likely to occur after intense rainfall.

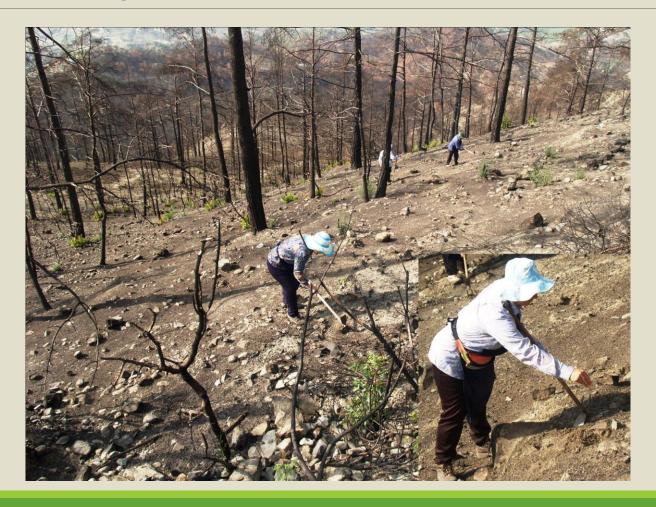
## **Sowing technics**

- Spot sowing
- Broadcast sowing

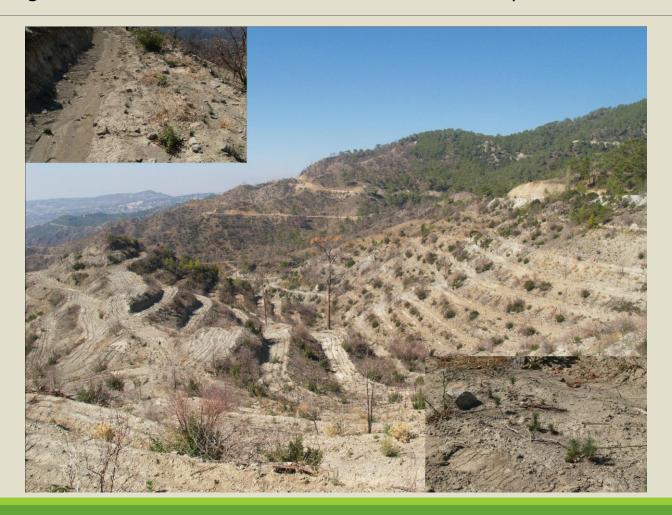
### **Cultivation of existing and construction of new terraces**

The particular treatment had been applied to areas where terraces have been established in the past along contour line and there were no natural reserves of pine-tree seeds.

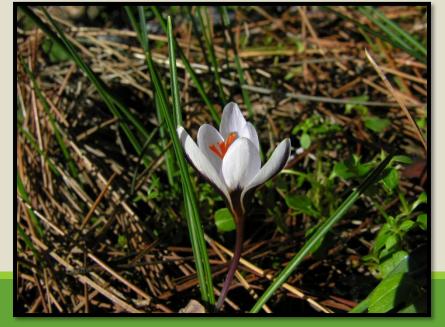
The rare endemic plant Crocus hartmannianus

- Delimitation of the distribution area of the endemic species, *Crocus hartmannianus*
- Crocus hartmannianus seed collection for their preservation in the seed bank
- Placement of waterers in selected points, supported by water tanks of 1000 L capacity
- Enhancement of the stream flow on rocky positions, for the creation of water ponds
- Placement of artificial nests for supporting the nesting of the local bird species
- Placement of artificial bat boxes
- Fruit tree planting (plant purchase and fencing),
- Construction of small ponds.
